MLB/SERV (MOTOR LIFE BOATS/SURFACE
EFFECT RESCUE VEHICLES) OPERATION
STUDY

MLB/SERV Unit

1 January 1973

MLB/SERV OPERATION STUDY

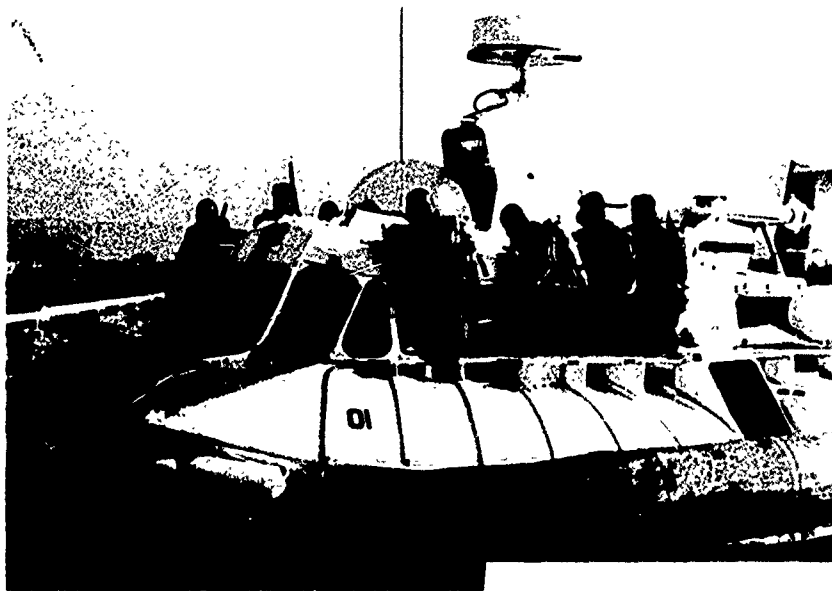
SERV on the ramp at Oakland International Airport 30 mins. after departure from Ft. Point. Rescue team positioned for deployment

The general consensus of the disaster recovery rescue personnel, with regard to the deployment from a SERV, was very favorable. Additionally, the rescue personnel indicated that the SERV was a much more suitable platform than that of a boat or helicopter, which had been tried in earlier studies. The significant advantage was the ease of deployment and retrieval of rescue personnel (Figure A-9), and the SERV's speed and amphibious capability. Comments concerning the study from the Alameda County Director of Civil Defense are provided in Figure A-10.

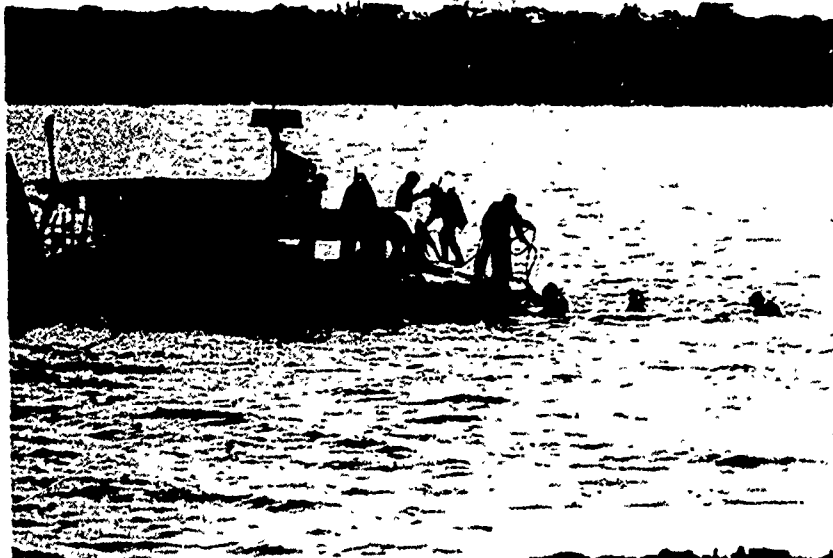
Rescue personnel being assisted aboard with two tenders using a bite of line

Bite of line placed between scuba tank and back harness. Tenders provide all required lift.

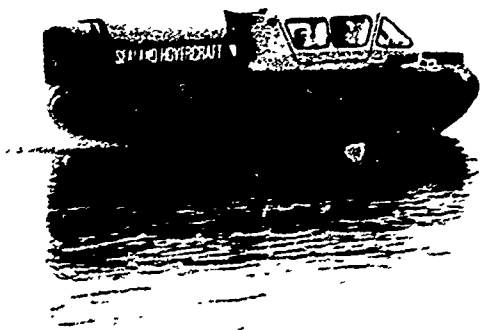
Figure D-11

SH-2 Hovercraft in Operation

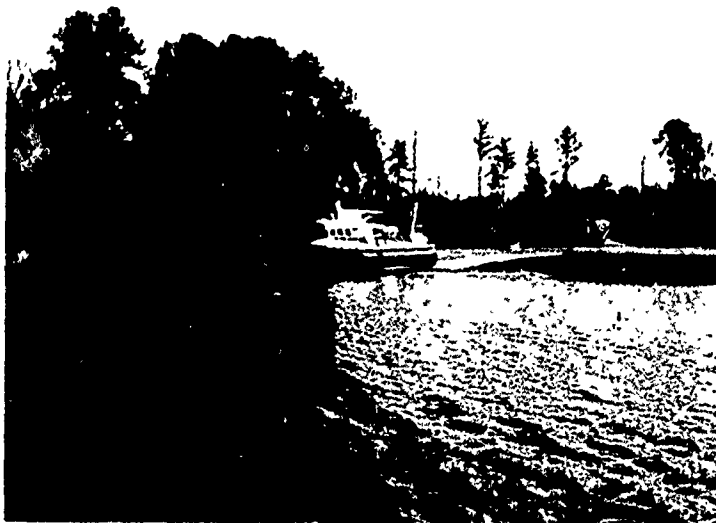
SERV operating ramp and
apron at CG Station Milford
Haven (Chesapeake Bay).

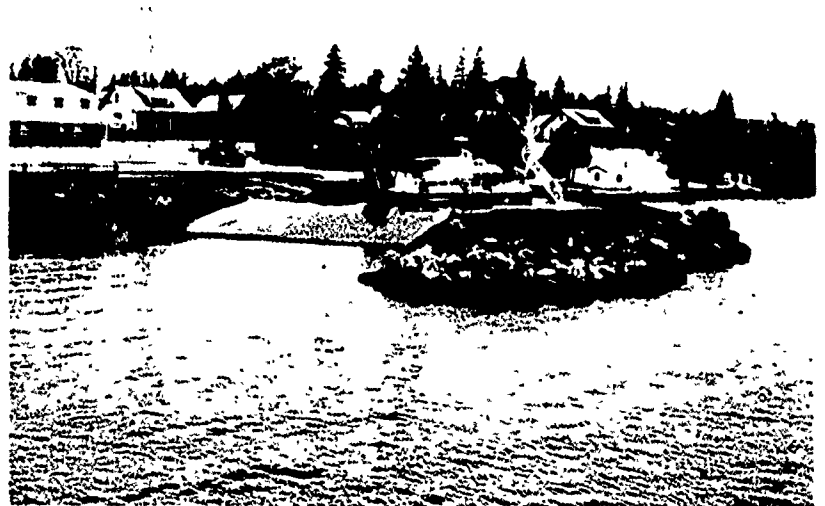
SERV operating ramp and
apron at Station St Ignace
(Northern Great Lakes)
summer.

Station St Ignace facility
during winter (obvious
requirement for sheltered
maintenance area).
